Similk Tidal Marsh Restoration Project

Basis of Design Report

Blue Coast Engineering LLC

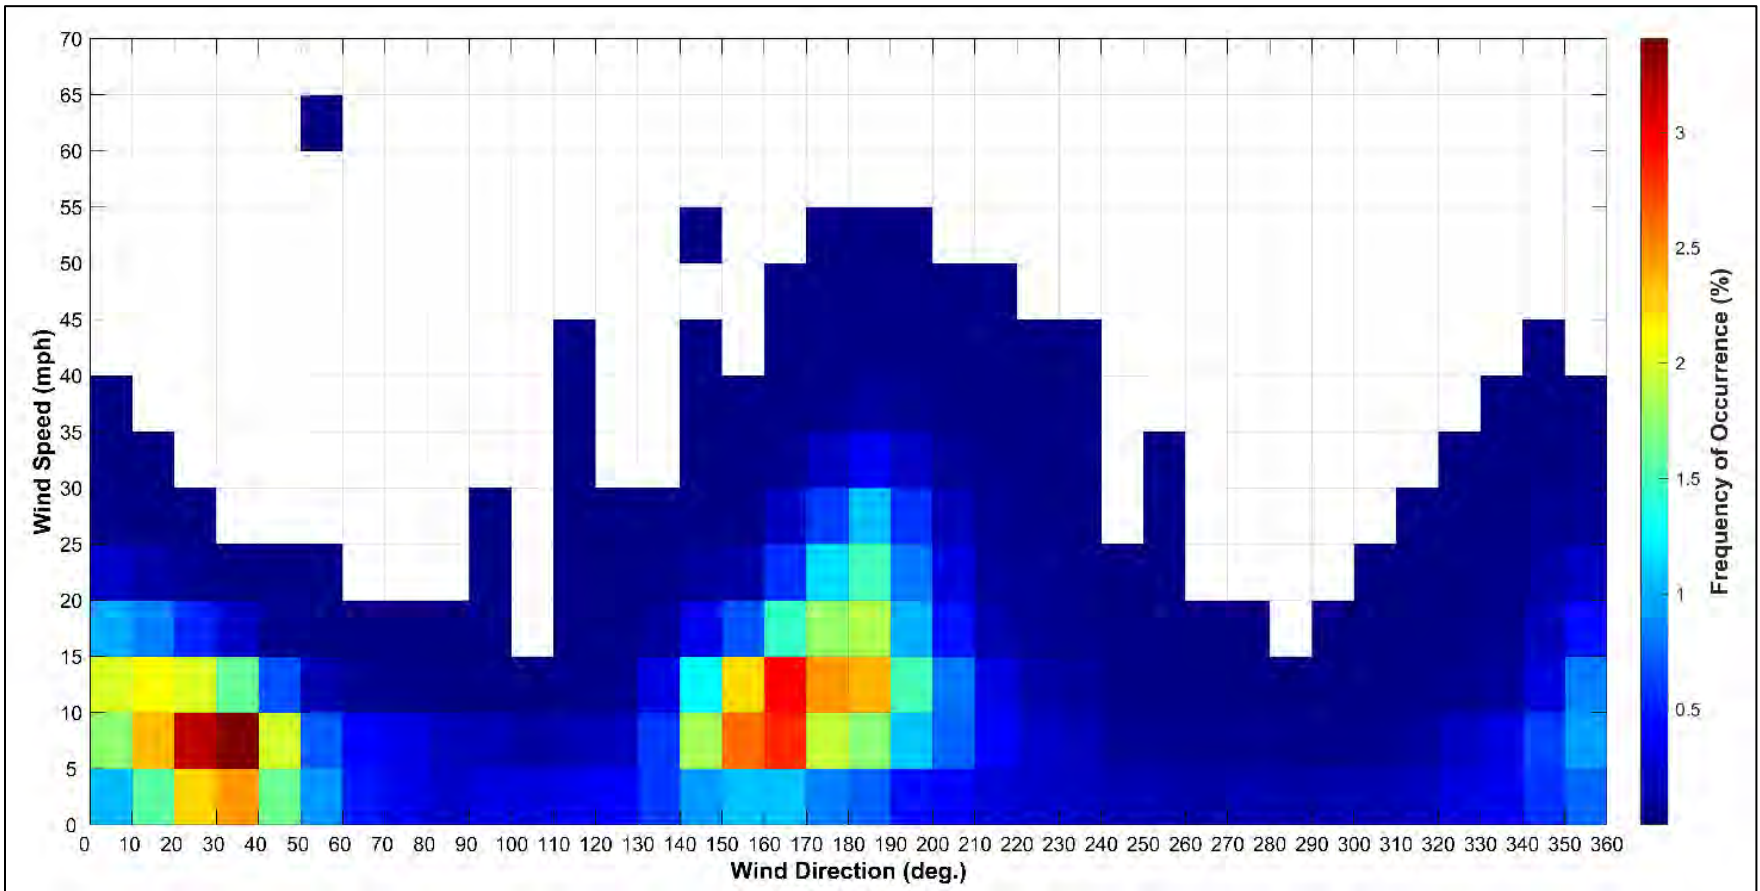
Figure 6: Joint probability plot of wind speed versus wind direction for the West Point meteorological station from 1975 to 2019.

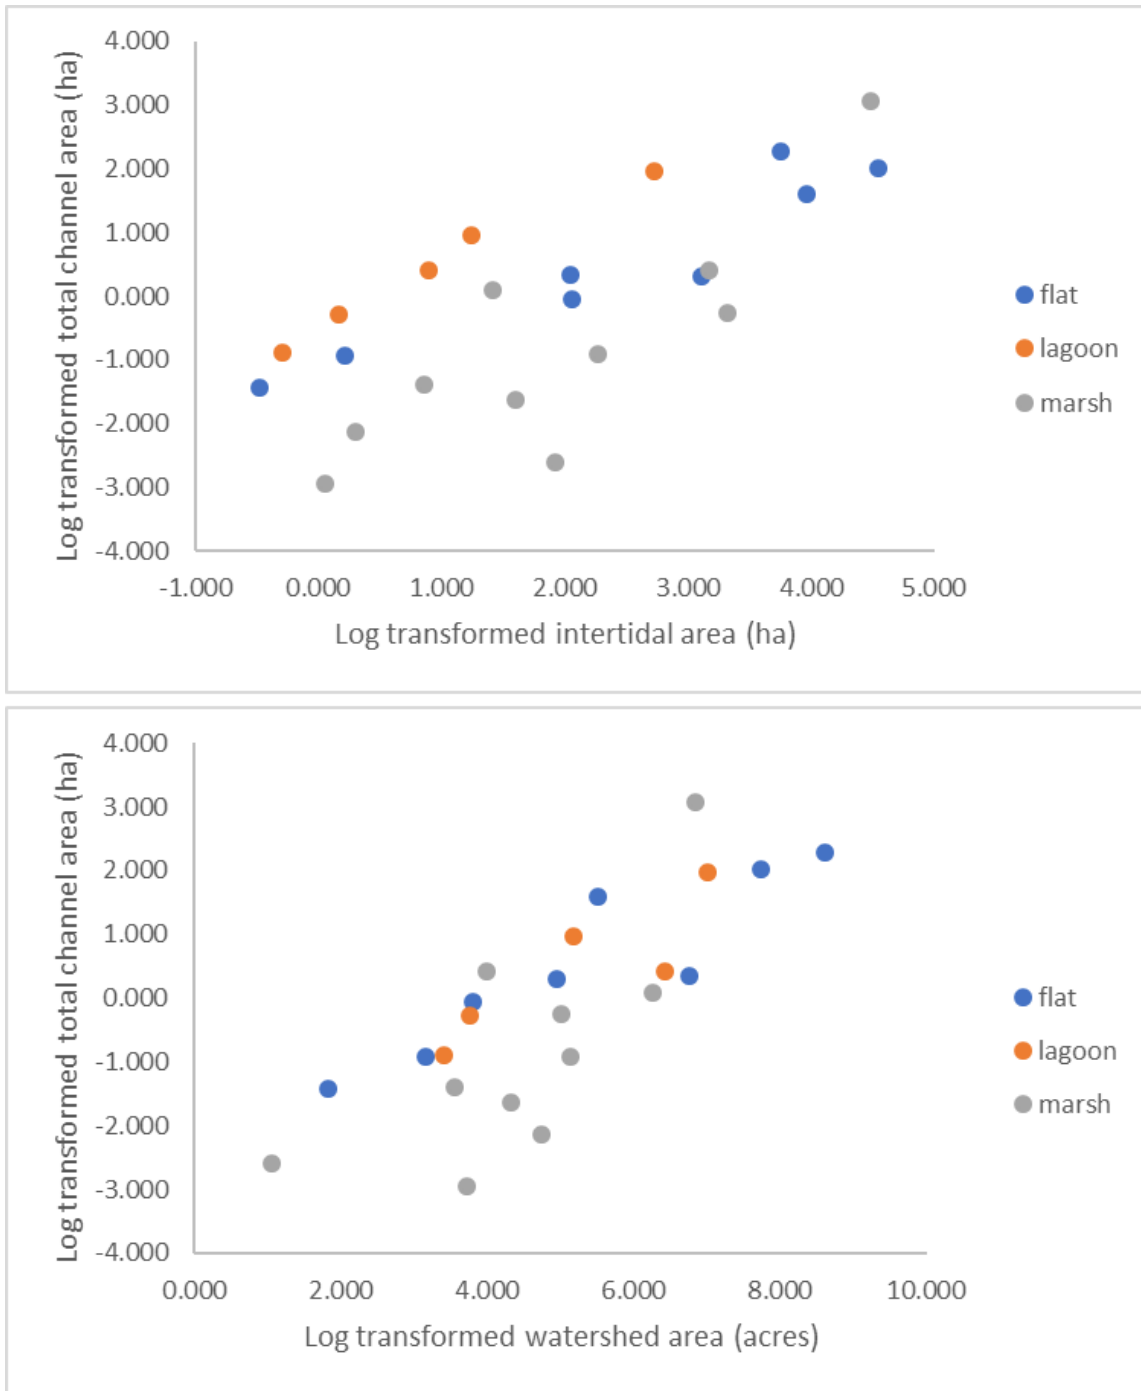
Figure 3. Scatterplot of intertidal area (top panel) and watershed area (bottom panel) and TCA by system type.

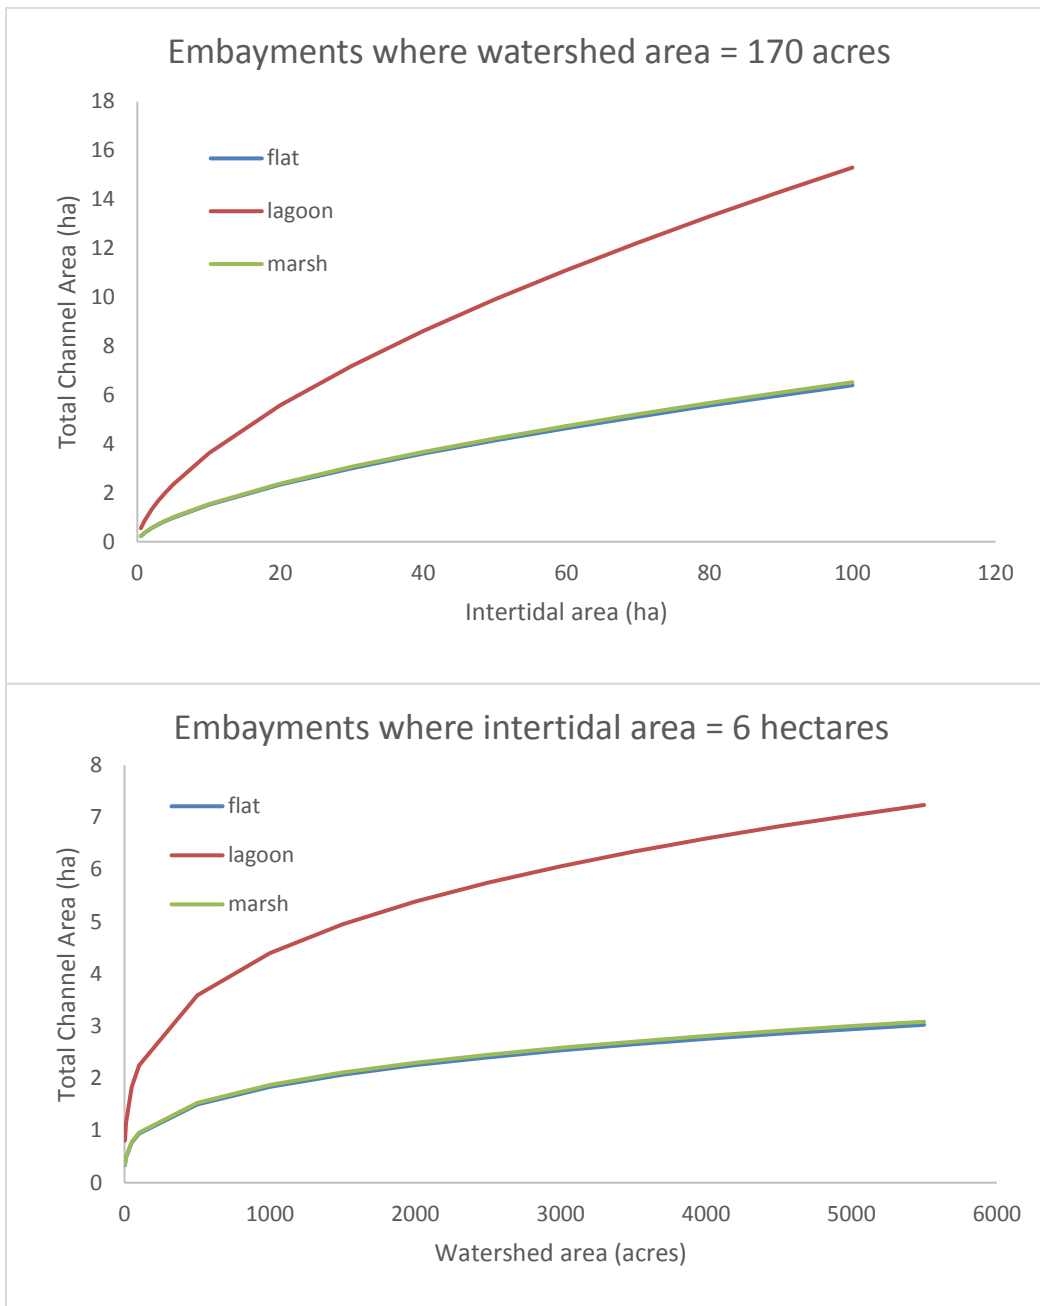
Figure 4. Predictions of TCA using best model which uses three variables: intertidal area, watershed area, and system type. *Top panel* shows the relationship as a function of intertidal area and system type with watershed area set at a constant 170 acres (rough approx. of watershed area to the Similk Restoration Project site). *Bottom panel* shows the relationship as a function of watershed area and system type with intertidal area set at a constant 6 hectares (rough approx. of potential intertidal area to the restored Similk Restoration Project site).

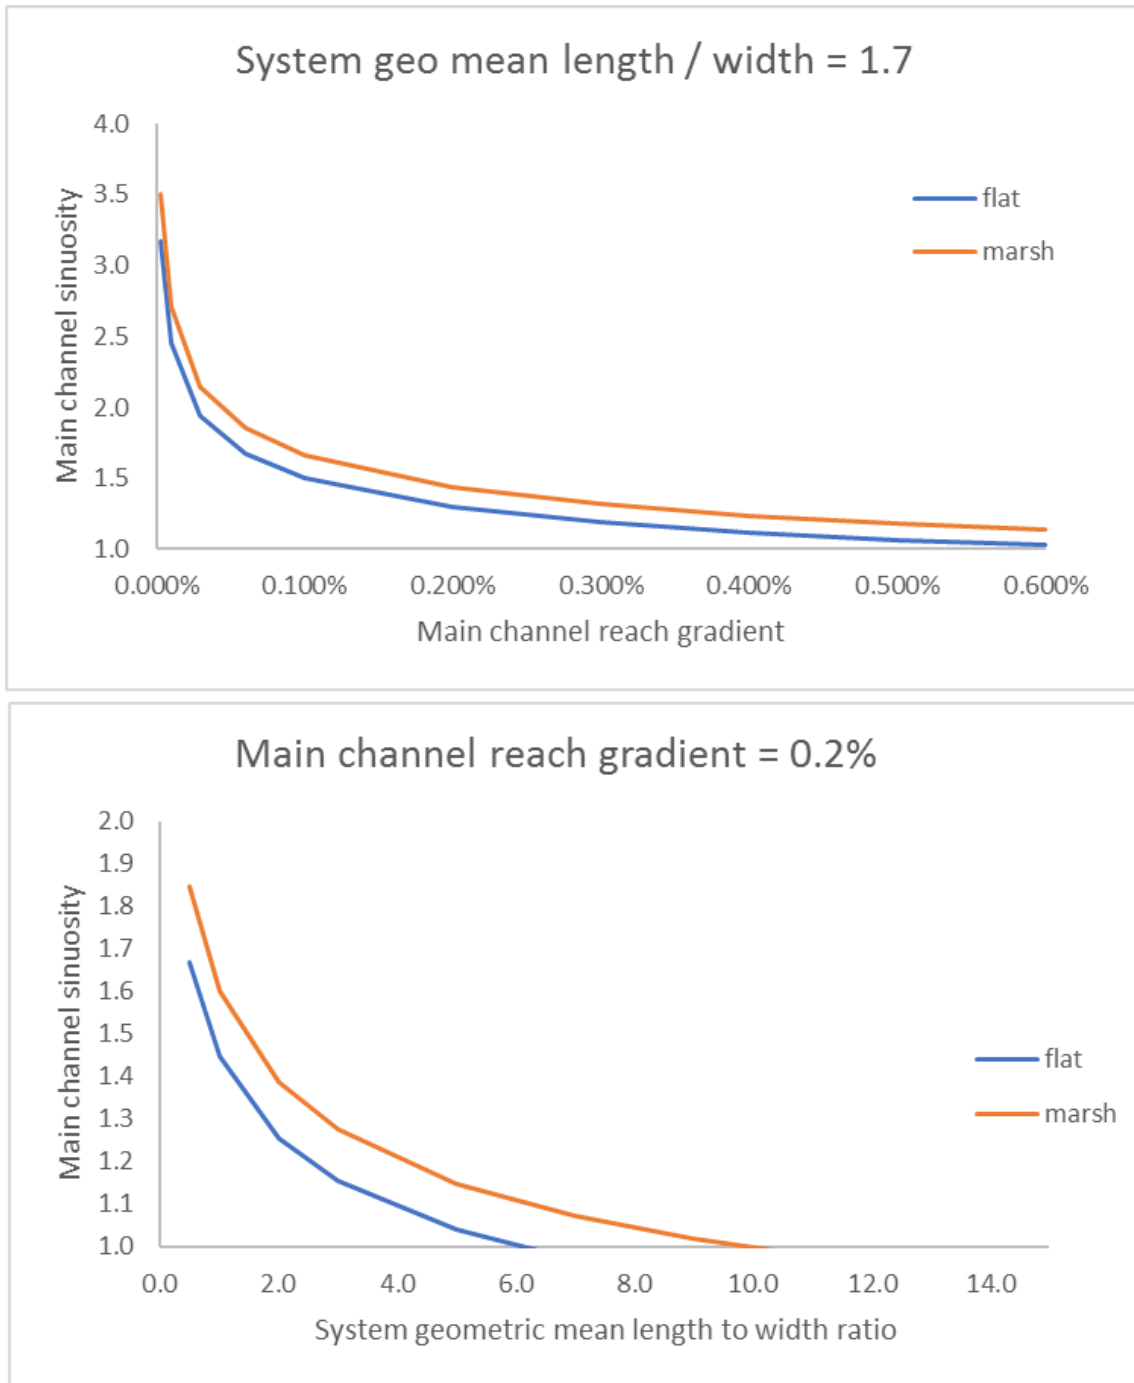
Figure 9. Predictions of MCS using best model (Table 7). Top panel shows the relationship as a function of main channel reach gradient and system type with system geometric length to width ratio set at a constant 1.7 (rough approx. of the Similk Restoration Project site). Bottom panel shows the relationship as a function of system geometric length to width ratio and system type with main channel reach gradient set at a constant 0.2% (rough approx. of the Similk Restoration Project site).

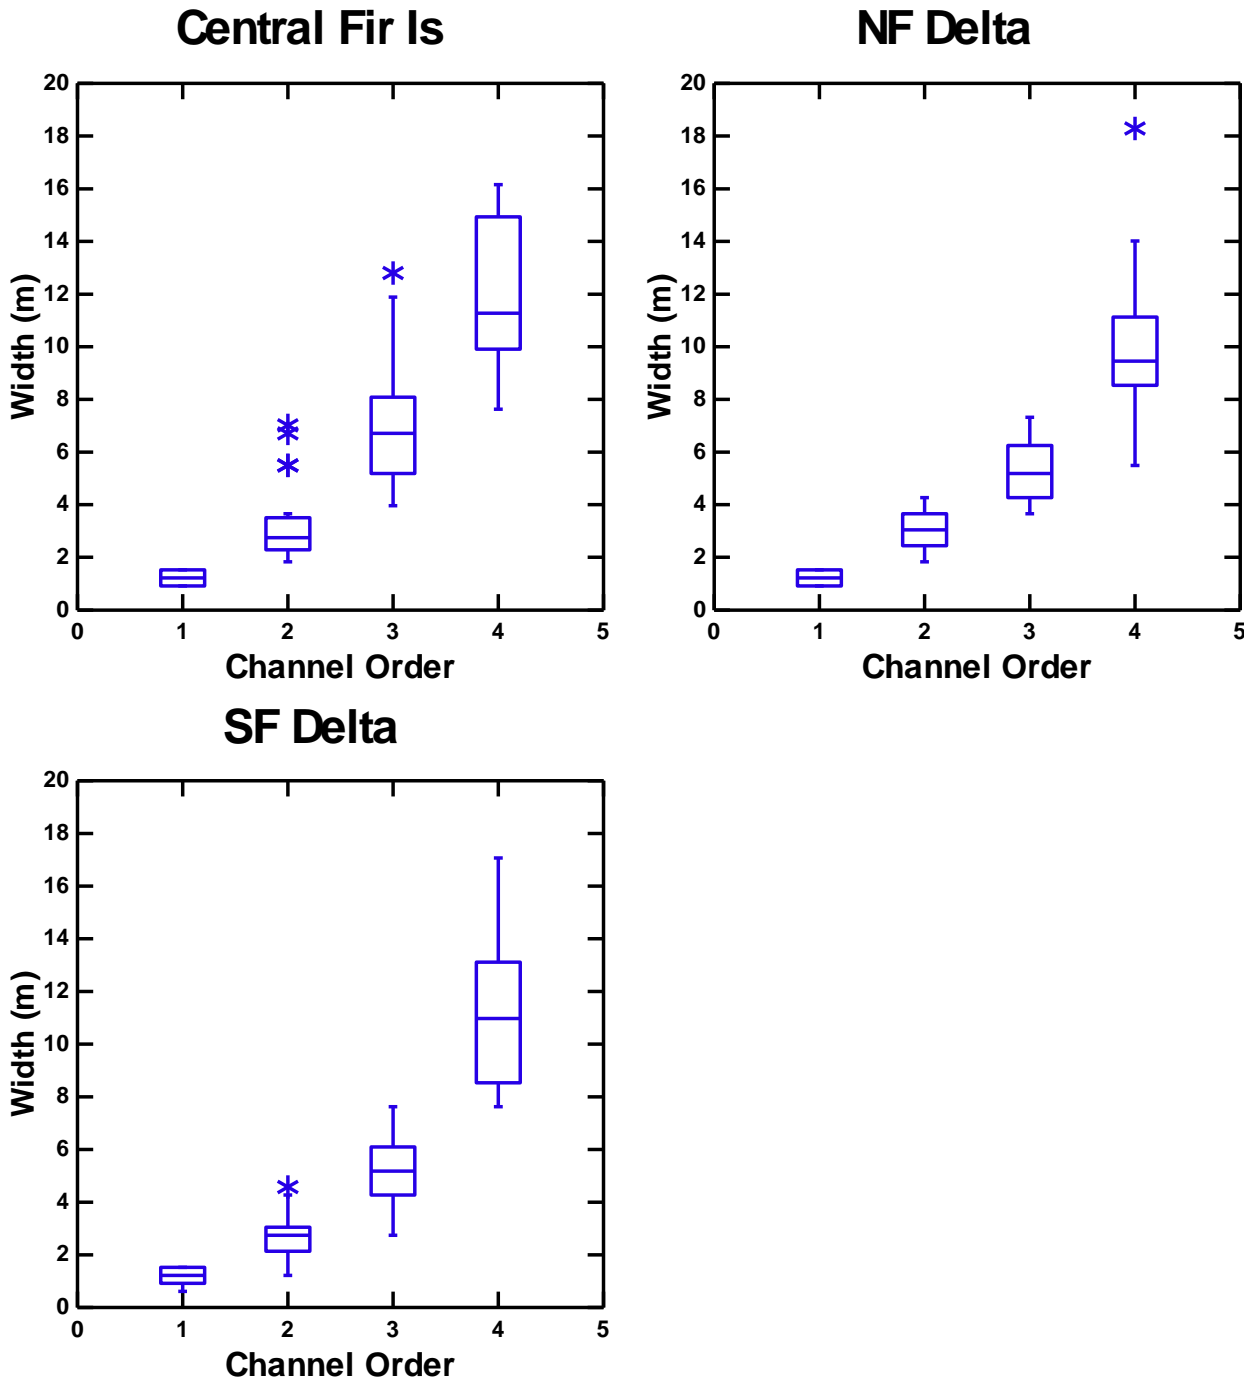
Figure 11. Boxplot of blind tidal channel top width in meters by channel order by three spatial strata within the Skagit tidal delta. The Central Fir Island results (top left panel) is most representative of barrier embayments.

The best supported model includes spatial bin and channel order to predict blind tidal channel top width (Figure 11., Table 10A-C). The relationship is best expressed as a power function so I natural log transformed channel width and channel order for the analysis. Blind channels within Central Fir Is are wider than both SF and NF delta channels of the same channel order (Table 10D). NF delta and SF delta channels are not significantly different in their width by channel order.

Recommendation: Since the Central Fir Is area has the least riverine and most tidal influence of the three Skagit tidal delta spatial bins, blind tidal channel characteristics from that area are likely more similar to barrier embayment channel characteristics than NF delta or SF delta channels. I recommend using the Central Fir Is channel width by channel order results as a surrogate for channel widths for design guidance at the Similk Restoration Project site (Table 11).

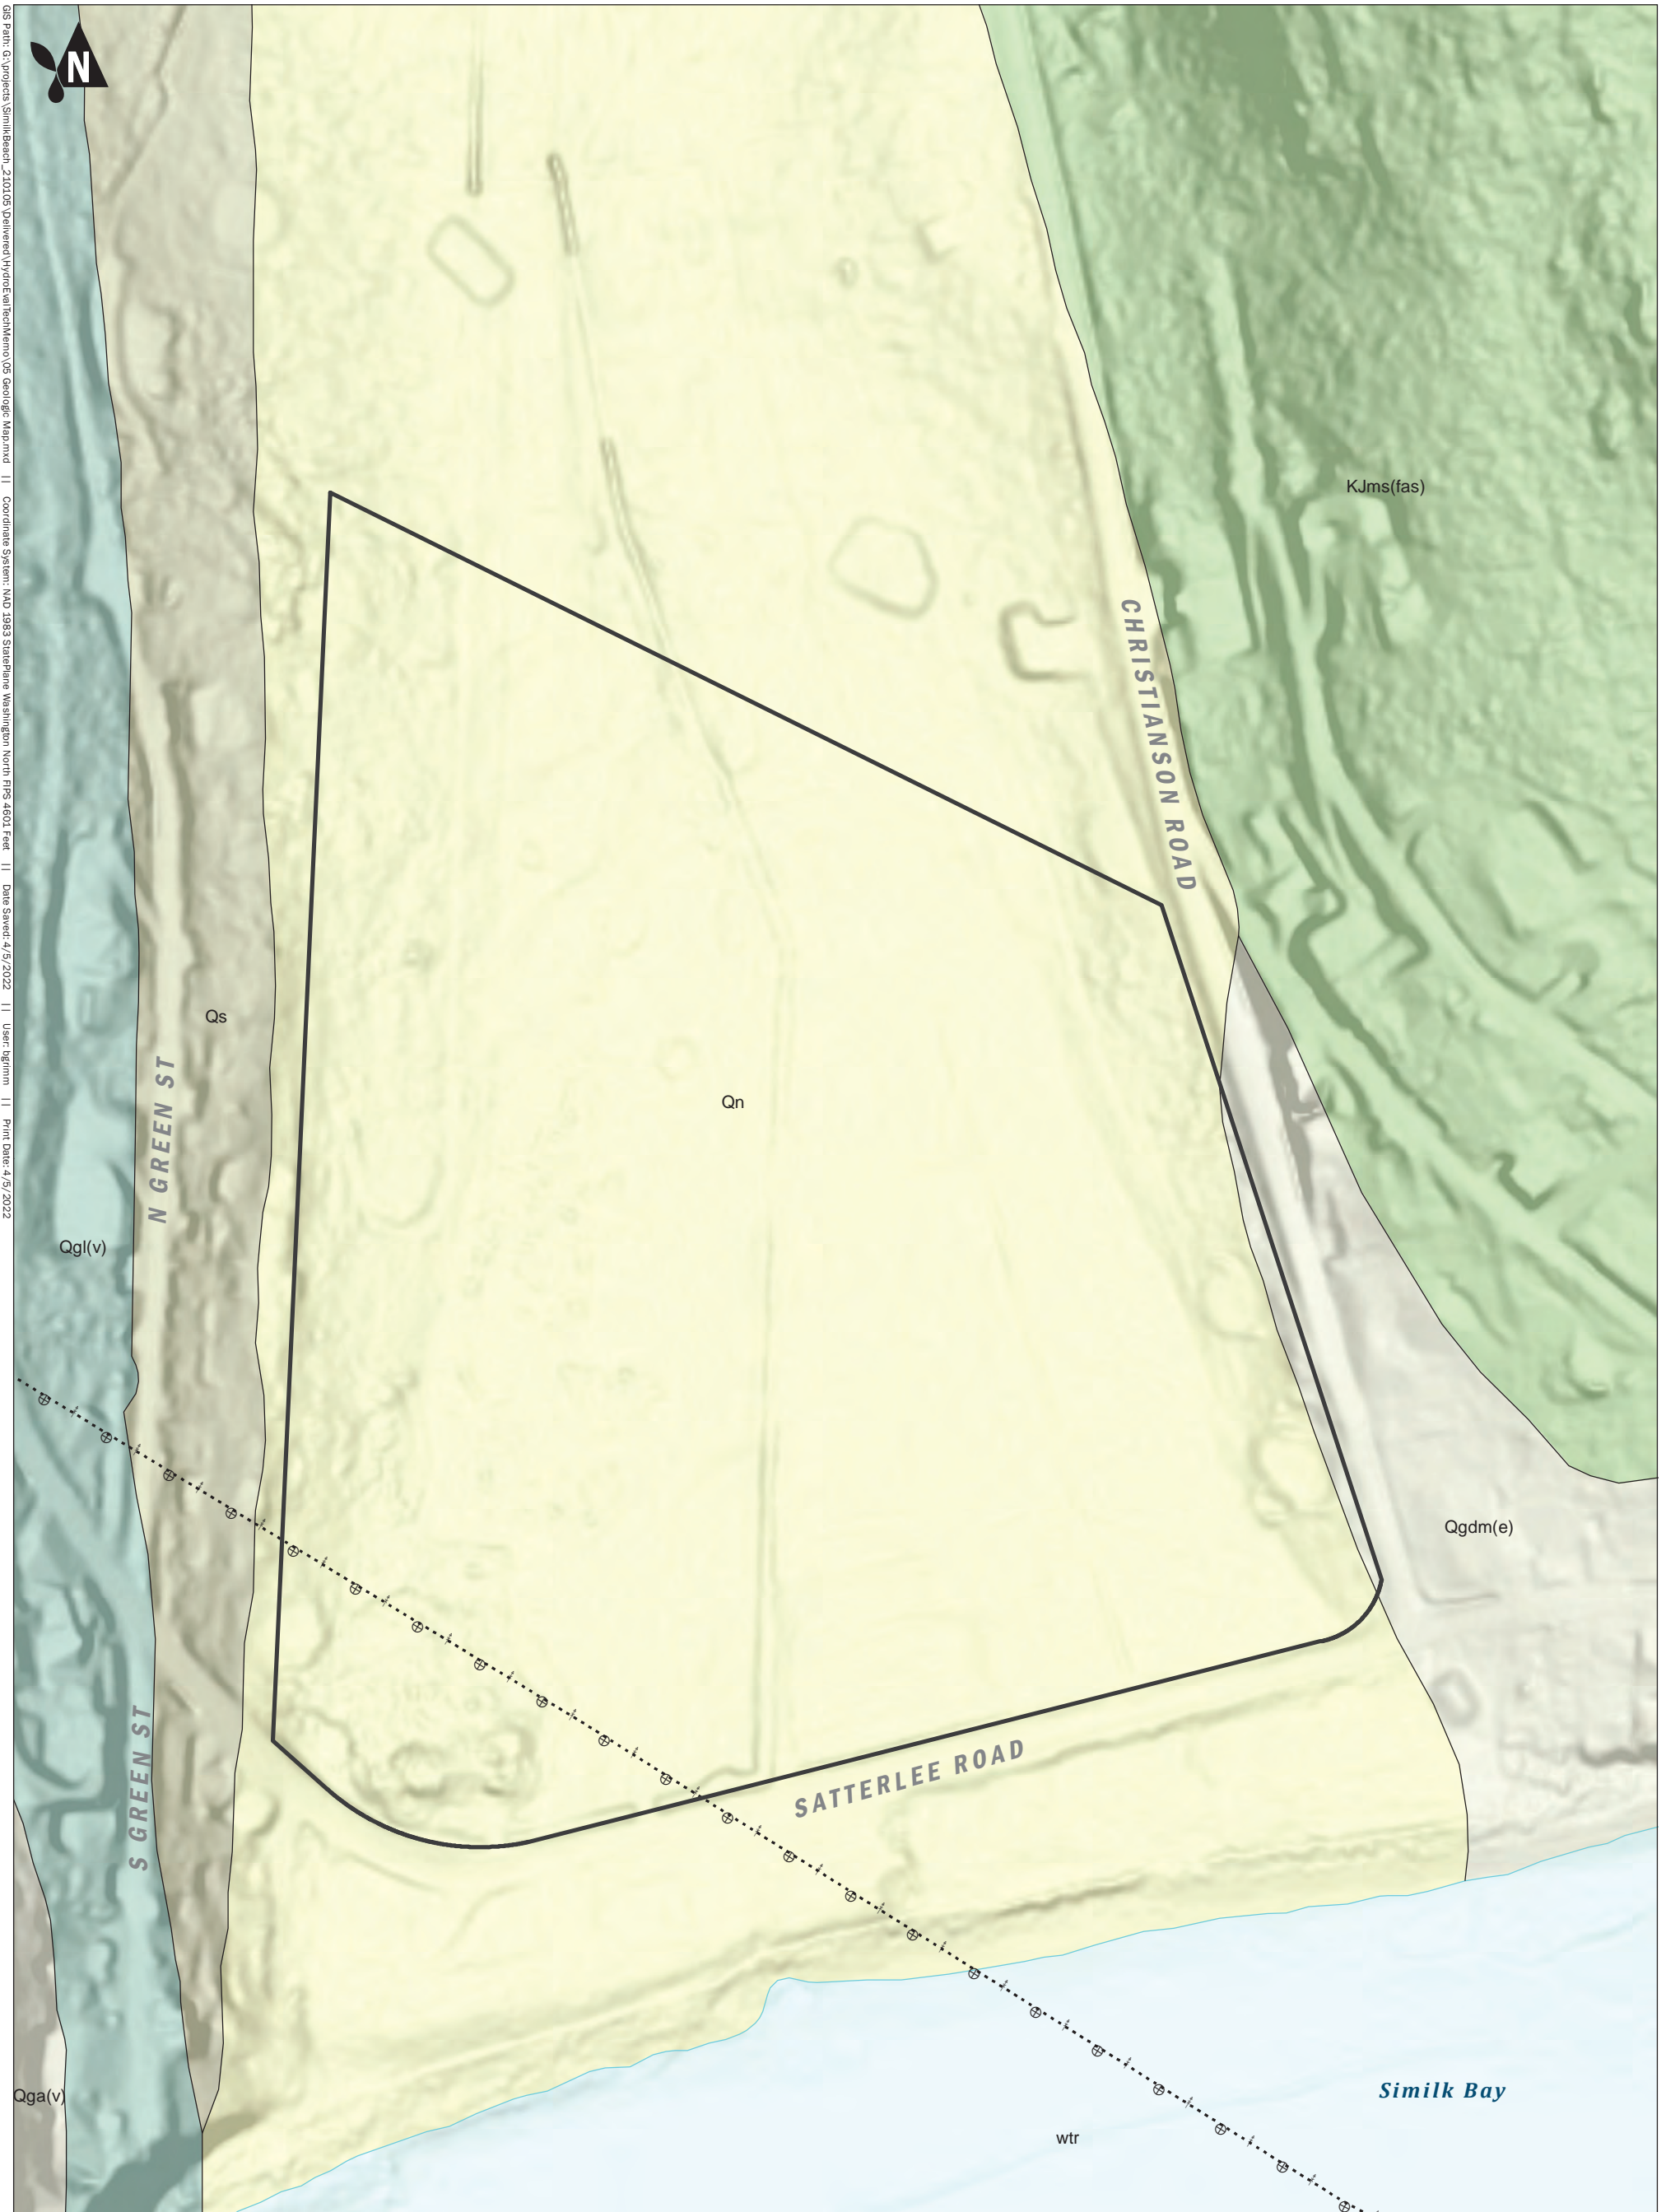
APR-2022	BY: SDM / WEG	FIGURE NO. 4
	PROJECT NO. 210105-A-001-4	REVISED BY: SDM / WEG

Geologic Map
 Hydrologic Evaluation Technical Memorandum
 Similk Tidal Marsh Restoration Project
 Skagit County, Washington
